Contract #: 04-0120F4Cty: SF/ALA Rte: 80 PM: 13.2/13.9File #: 69.28**WELDING INSPECTION REPORT****Resident Engineer:**Siegenthaler, Peter**Address:** 333 Burma Road**City:** Oakland, CA 94607**Report No:** WIR-022421**Date Inspected:** 04-Apr-2011**Project Name:** SAS Superstructure**OSM Arrival Time:** 700**Prime Contractor:** American Bridge/Fluor Enterprises, a JV**OSM Departure Time:** 1900**Contractor:** Zhenhua Port Machinery Company, Ltd (ZPMC), Changxing Island **Location:** Shanghai, China**CWI Name:** Mr. Liang**CWI Present:** Yes No**Inspected CWI report:** Yes No N/A**Rod Oven in Use:** Yes No N/A**Electrode to specification:** Yes No N/A**Weld Procedures Followed:** Yes No N/A**Qualified Welders:** Yes No N/A**Verified Joint Fit-up:** Yes No N/A**Approved Drawings:** Yes No N/A**Approved WPS:** Yes No N/A**Delayed / Cancelled:** Yes No N/A**Bridge No:** 34-0006**Component:** Orthotropic Box Girder(OBG)**Summary of Items Observed:**

OBG Trial Assembly open yard.

Segment:13AW

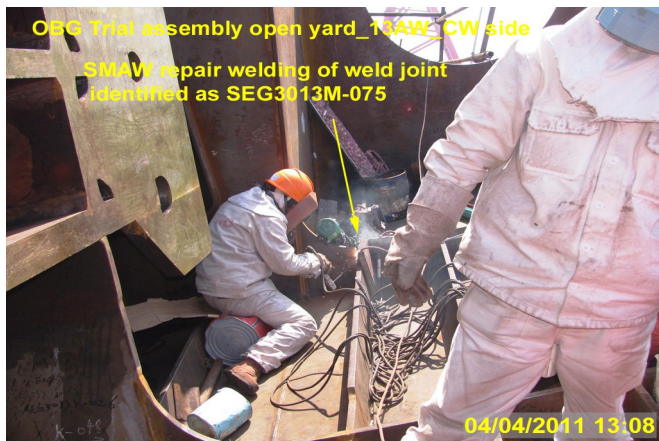
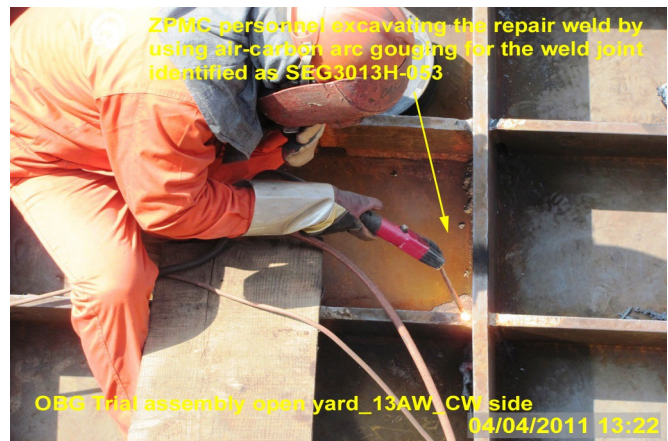
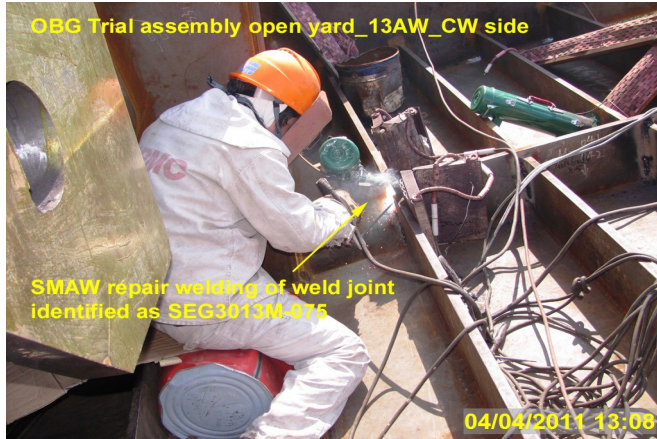
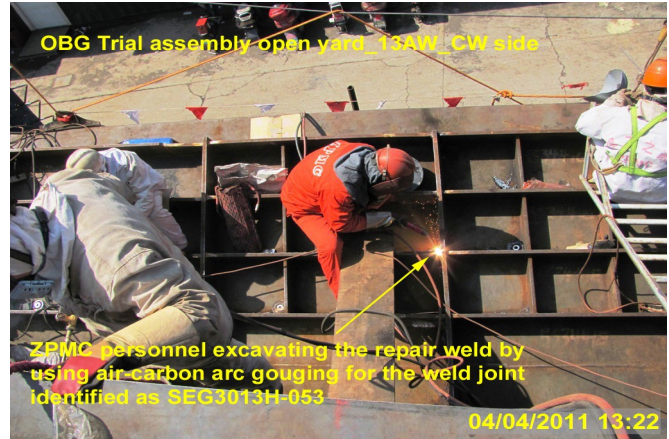
SMAW repair welding of weld joint identified as SEG3013M-075. Welder is identified as 067572. ZPMC QC is identified as Mr. Shen jian bo. The welding variables recorded by QC personnel observed appeared to comply with WPS: WPS-345-SMAW-4G (4F)-FCM-repair-1. The repair welding was being performed as per Welding Repair Report (WRR) No: B-WR20579. See attached photos for further information.

ZPMC personnel excavating the repair weld by using air-carbon arc gouging for the weld joint identified as SEG3013H-053 at Panel point 119 cross beam side. This weld repair was being performing as per the WRR-BWR20578. See attached photos for further information.
